## **SUMMARY OF ANALYSIS**

**By: James S. Sobek, P.E.**  
**On: March 10, 2021**

**Your Reference: Motor Vehicle/Bicycle Accident March 31, 2017 – Mike Hall**  
**Wolf Project No.: 21-0038-4937**

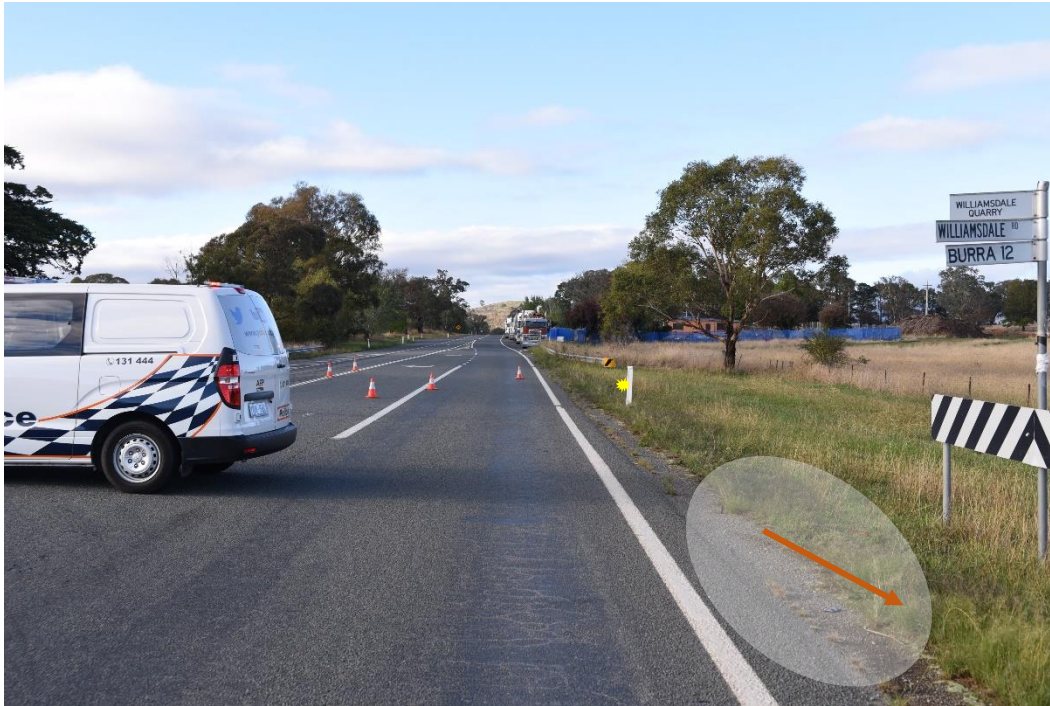
Figure 5 Looking south from Williamsdale Road intersection. The approximate point of impact is marked by the yellow explosion symbol. Several pieces of bicycle debris were found in the area marked by the oval. The red arrow points to one piece of the bicycle's rear wheel.

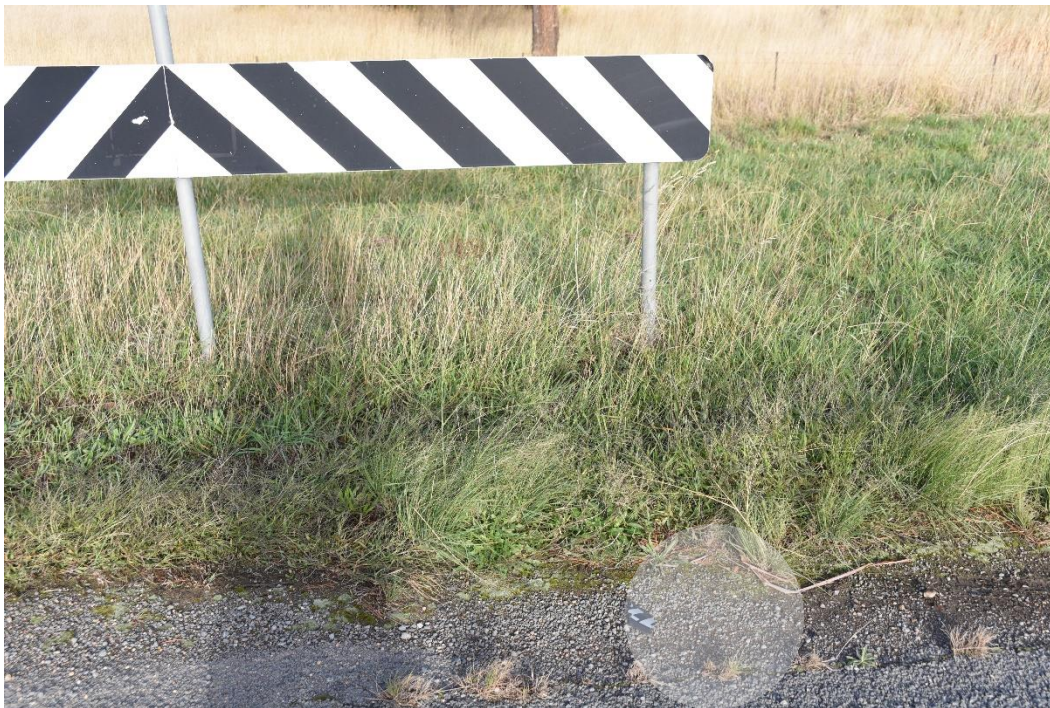
Figure 6 Looking west from a position on the west edge of Monara Highway. The black/white sign is directly across from the Williamsdale Road intersection. The light circle surrounds the piece of the bicycle's rear wheel marked in Figure 5.

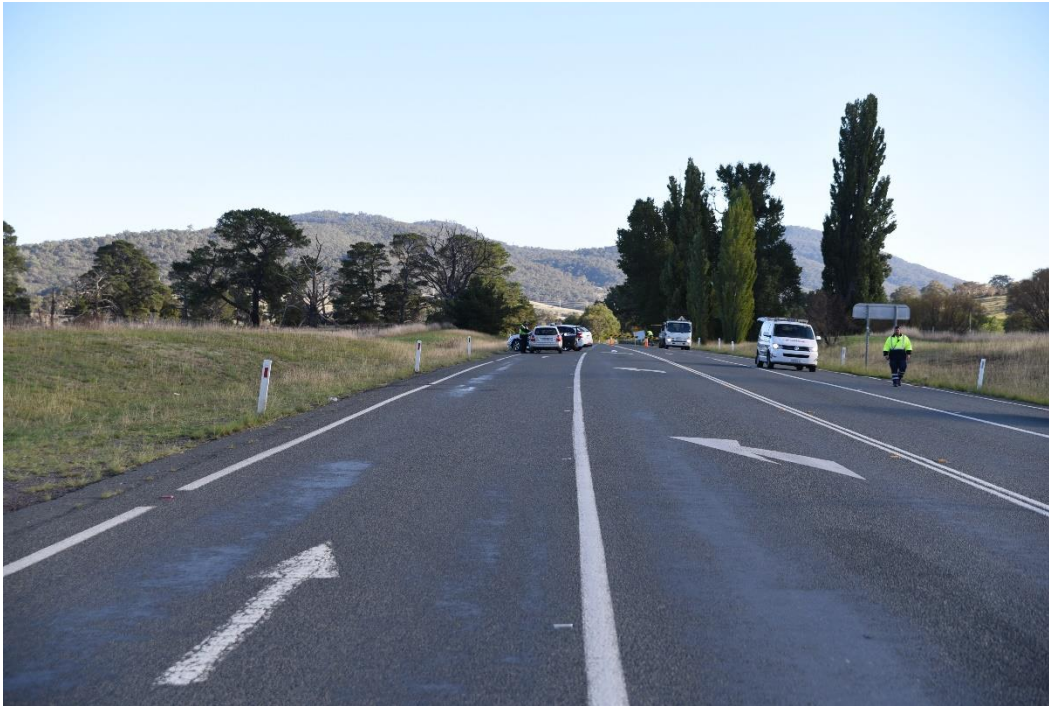
Figure 7 Looking north along Monara Highway toward the car and bicycle at rest.

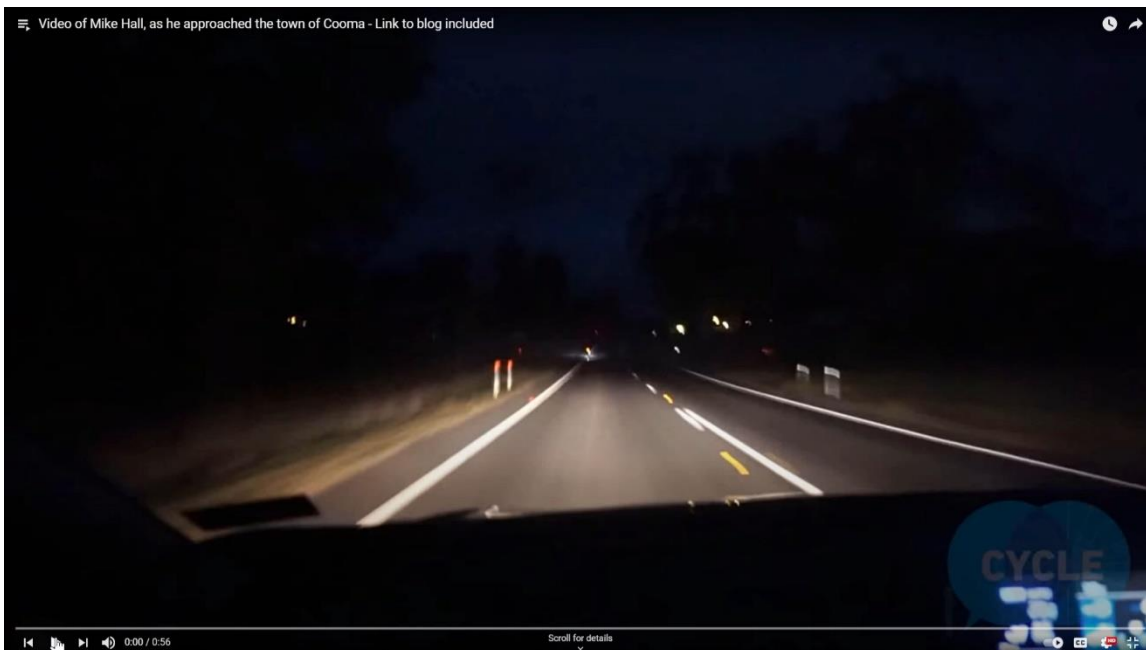
The first frame of the video clearly shows a bright bluish-white patch of light centered on the left fog line of the pavement and an intense red light taillight above the white pavement patch and moving north with it. The red light was so intense that the picture elements where its image was focused became saturated and presented it as white. This is a common property of a digital camera. Human visual systems will still see the light as red.

**Figure 8** The first frame of the approach video taken on March 30, 2017. At this time the bicycle was on the fog line about 60 meters in front of the car.

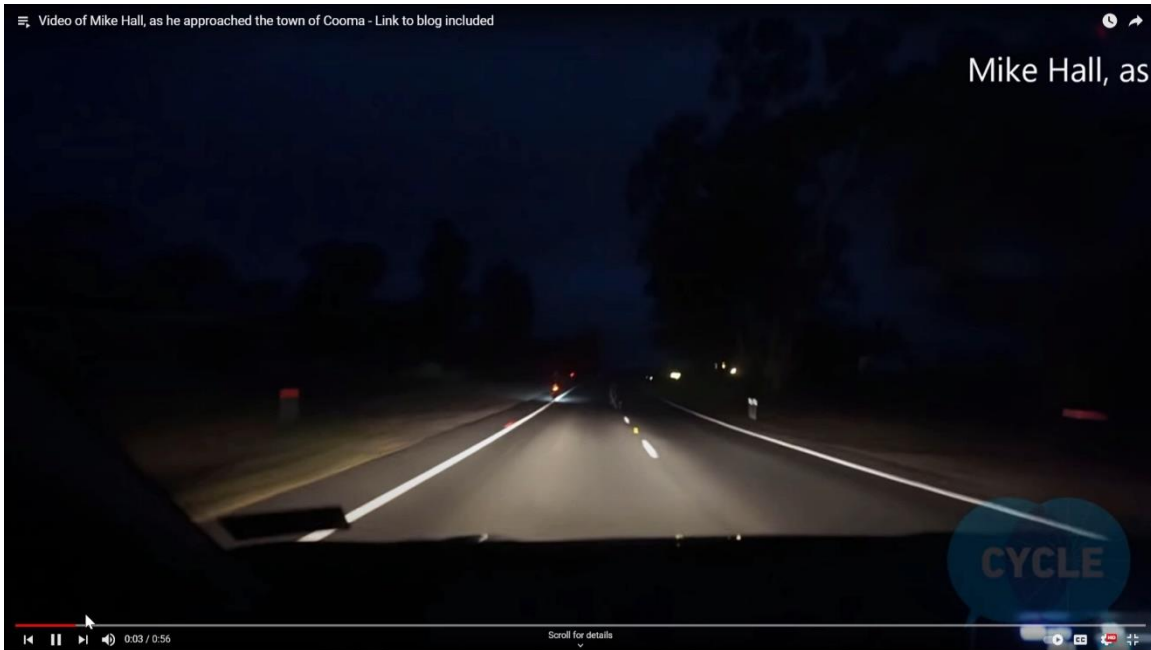
Shortly afterward, as the car approached, a left-right waggle of the bicycle's headlamp pattern caused by lateral dynamics of the rider and bicycle became evident as it swayed left and right across the fog line.

**Figure 9** This frame is 3 seconds into the video. The left-right motion of the bicycle's headlight pattern has become noticeable by this point.

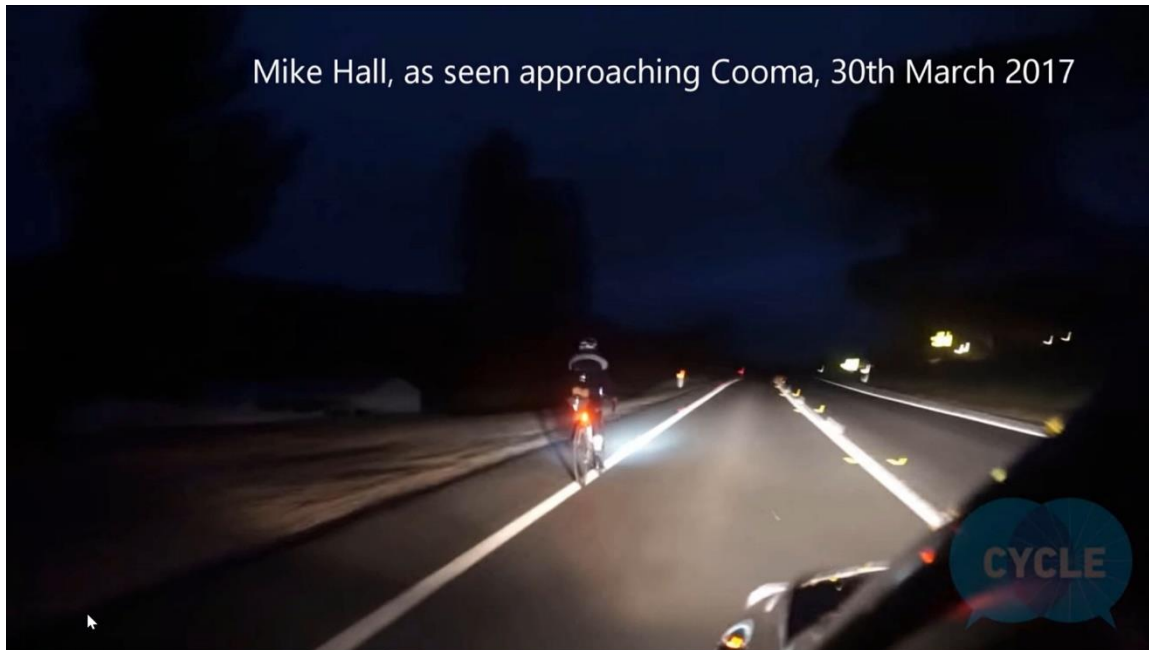
As the car got closer, the retro-reflective bands on Mr. Hall's pant legs became visible as did the silver retro-reflective shoulder yoke on his jacket and the silver retro-reflective band around the lower rim of his helmet. The biological motion of his legs alternately moving up and down made it clear that this was not a static rider, but one who was pedaling and making way northward along the road.

Figure 10 The retro-reflective elements of Mr. Hall's clothing are clearly seen. The up-down motion of the silver band on his right pant leg is obvious, although the left one was hidden in shadow at this point.

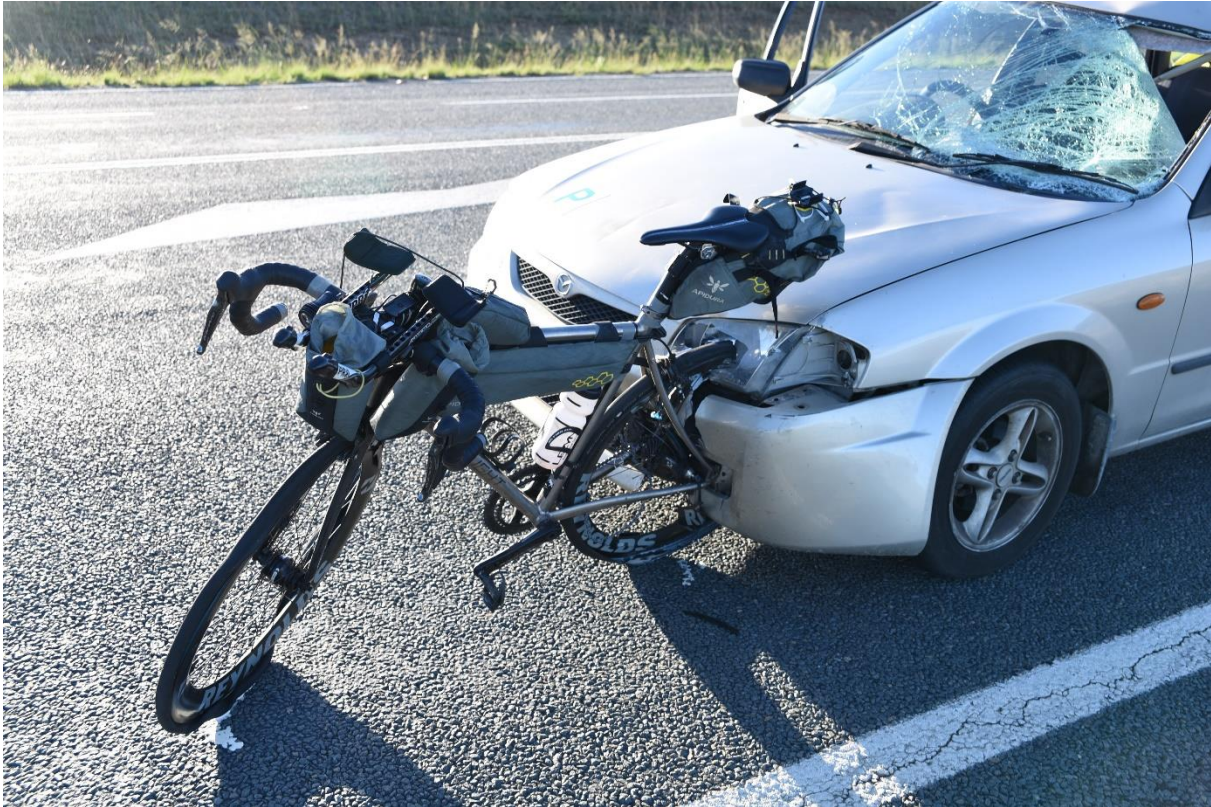
The left front corner of the Mazda 323 collided with the rear wheel of Mr. Hall's bicycle. When the car came to rest, the bicycle's rear wheel was still imbedded in the car's left headlamp assembly.

**Figure 11** A police scene photograph showing the bicycle and car at rest.

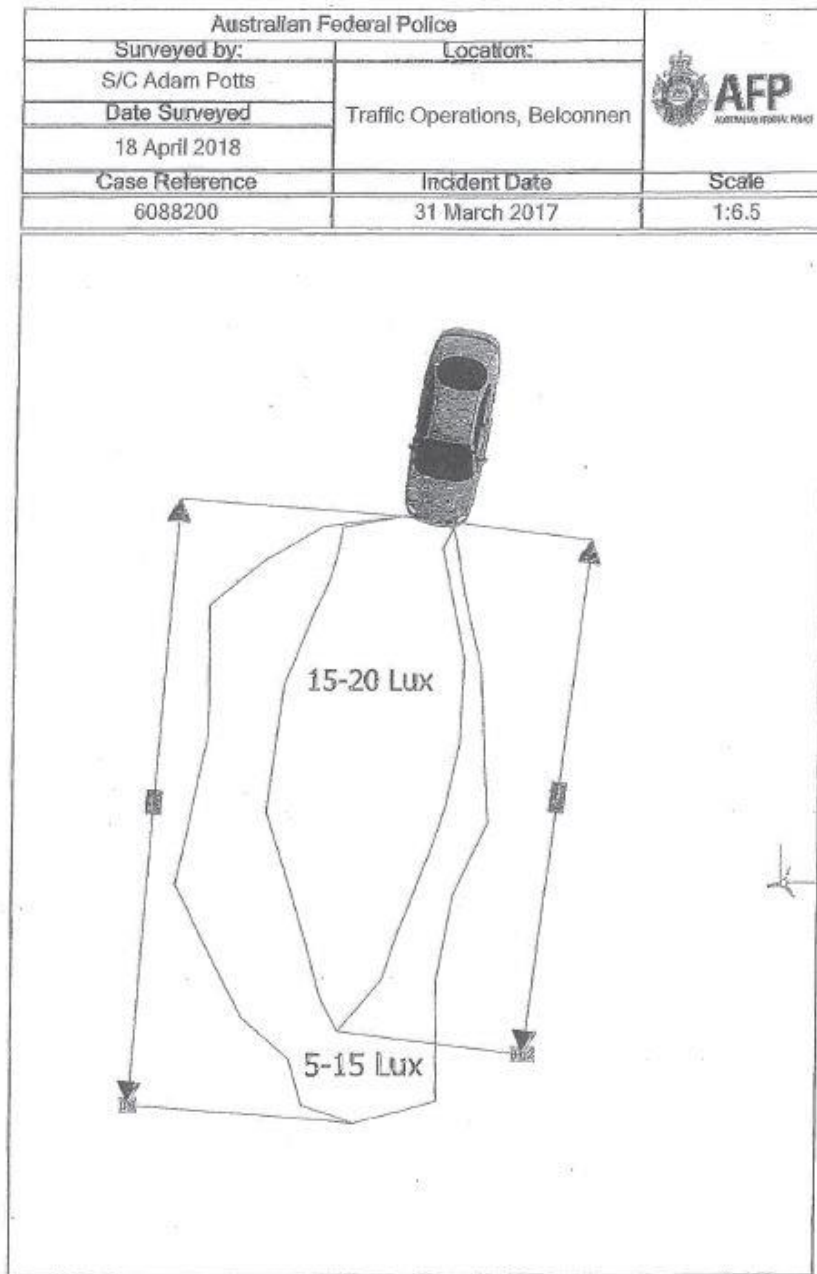
Based on what we can make of Senior Constable Potts’ statement, he seems to have first traced out the line **on the pavement** where the meter read between 15 lux and 20 lux. He then traced out another line where the meter read between 5 lux and 15 lux. But, neither of these is an

isolux curve. His phraseology of saying “between A and B” is just not clear and is not consistent with measuring an isoilluminance curve.

Figure 14 The scale diagram that S/C Potts produced from his data.

As best we can tell, Senior Constable Potts determined that the right headlamp of the Mazda 323 would only produce 5 lux at 15 meters. Inserting that into the inverse square law, we find that the intensity of the right lamp on the ray that he was measuring was 1125 candela, less than half of the required 3751 candela.

Again using the inverse square law, at 25 meters distance, one lamp with intensity of 1125 candela will only produce 1.8 lux. And two lamps, both with that same intensity will produce only 3.6 lux onto a target at 25 meters.

What we can say based on how Senior Constable Potts described his measurements is that the Mazda 323 driven by Mr. Bobb did not comply with ADR 46/00 and it was therefore not roadworthy.
