## **SUMMARY OF ANALYSIS**

**By: James S. Sobek, P.E.**  
**On: March 10, 2021**

**Your Reference: Motor Vehicle/Bicycle Accident March 31, 2017 – Mike Hall**  
**Wolf Project No.: 21-0038-4937**

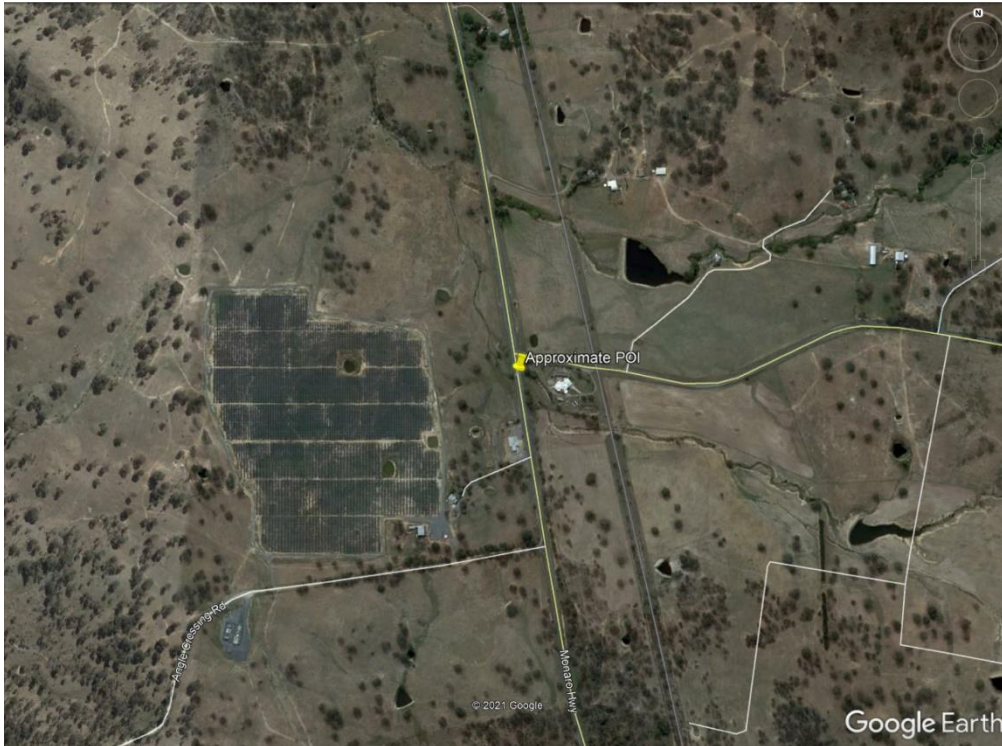
**Figure 3** The yellow pin marks the collision site. Mr. Hall was just approaching Williamsdale Road northbound when he was struck from behind.

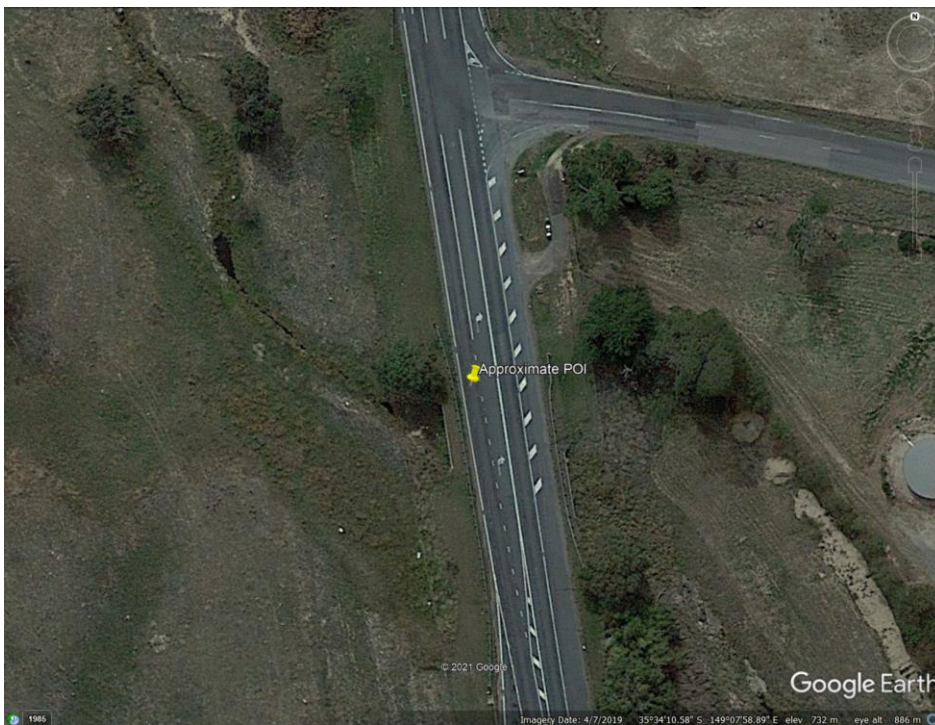
**Figure 4** A closer view of the site.
